Repairing water leaks in the TR-19 cyclotron: A case study in what not to do. MJ Schueller, DJ Schlyer. Medical Department, Brookhaven National Laboratory, Upton, NY 11973, USA.

In early September, 2009, a water leak opened up in one of the dees of BNL's ACSI TR-19/9 cyclotron. Attempts to patch the leak in place failed, so the dee was removed, repaired and replaced. After a week of operation, a nearly identical leak opened in the other dee. This began a chain of failures in the cyclotron, leading to approximately 8 months of down time in the human PET program at BNL. Multiple water leaks, burned internal components, and two new dees later, the machine is back to running stably.

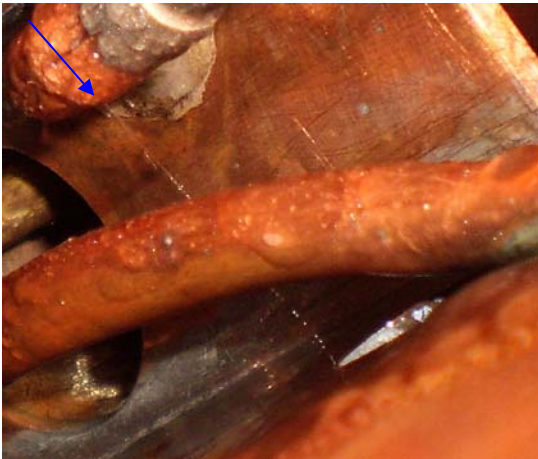
The first leak, in an elbow near the dee stem.

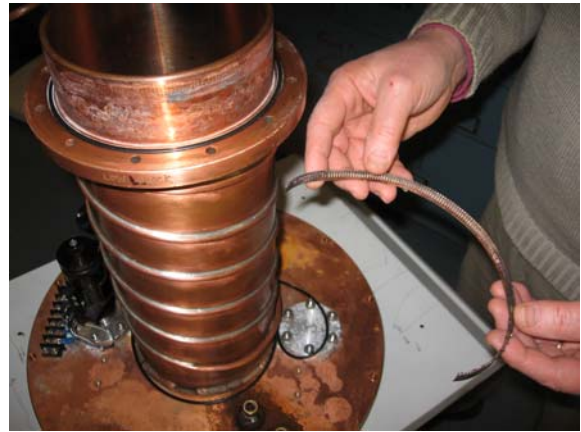
An attempt by BNL to replace burned fingerstock in situ failed. The cold solder joint held for a few weeks.

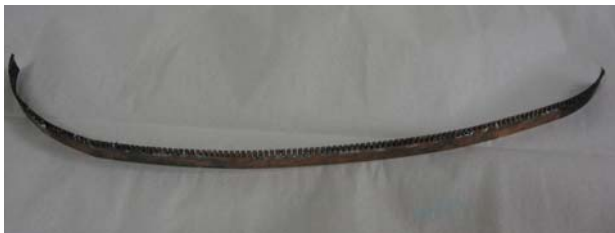
Fingerstock shouldn't look like this. When we opened the vacuum tank and smelled burned flux we knew we had a problem.

This issue was finally resolved with ACSI providing a replacement part with factory-soldered fingerstock.

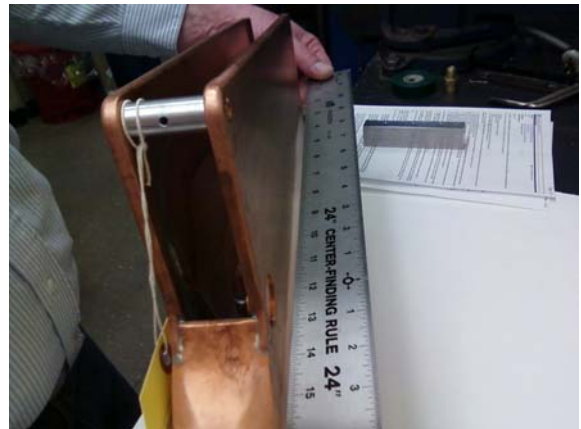
The new lower dee was installed and aligned, then removed to replace the burned fingerstock. At some point, it became bent ~2mm at the dee tip. Made of 7mm copper, it did not bend back easily. The cause is unknown.
